Maps Showing Seismicity Regions

Rapid Visual Screening of Buildings for Potential Seismic Hazards

Rapid Visual Screening of Buildings for Potential Seismic Hazards (FEMA 154)

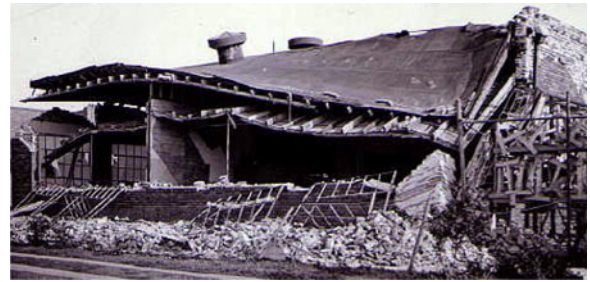
Figure F-11 Collapse of unreinforced masonry bearing wall, 1933 Long Beach earthquake.

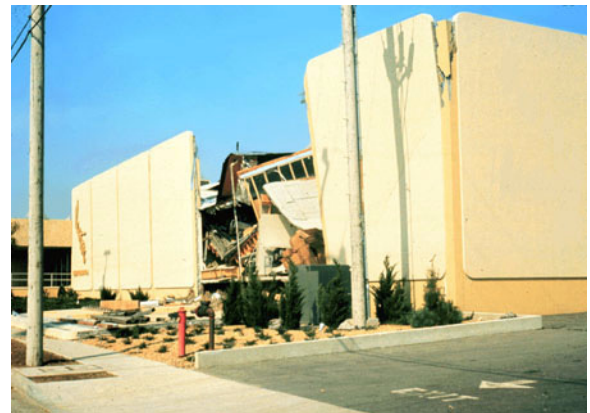
Figure F-12 Collapse of a tilt-up bearing wall.
